# KEY INSPECTION SERVICES

# Key Inspection Services, LLC

## Photo Attachments

**File Name** HappyClient\_InspectionReport\_4.26.2006

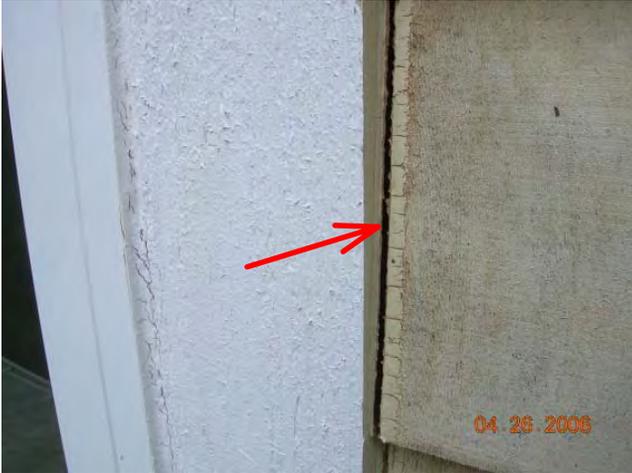
Failed caulking <window trim above garage>

1. Maintenance **Type:** Wood - All gaps seems, joints, and nicks on exterior components should be caulked and or painted as appropriate to prevent future moisture entry.

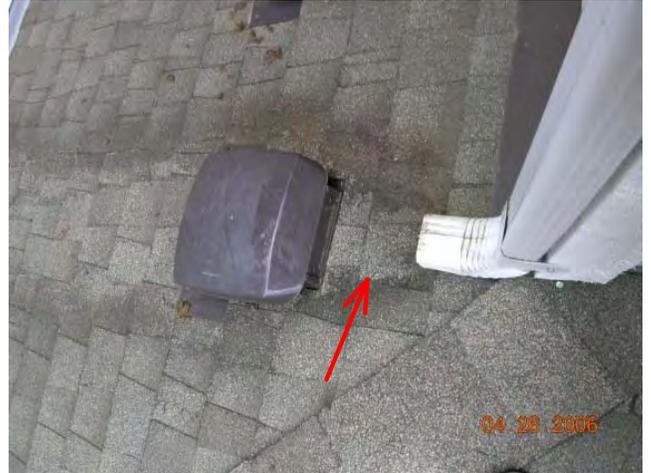
Downspout discharging directly into lower vent  
<front left above garage>

**Downspouts:** Metal - Recommend rerouting downspout off front left of garage, discharging directly on lower vent. Potential moisture entrypoint. (Damaged/Missing) Missing or damaged downspouts in numerous locations. Recommend repair/replacement to ensure water is properly control to dissipate away from the structure <front right>.

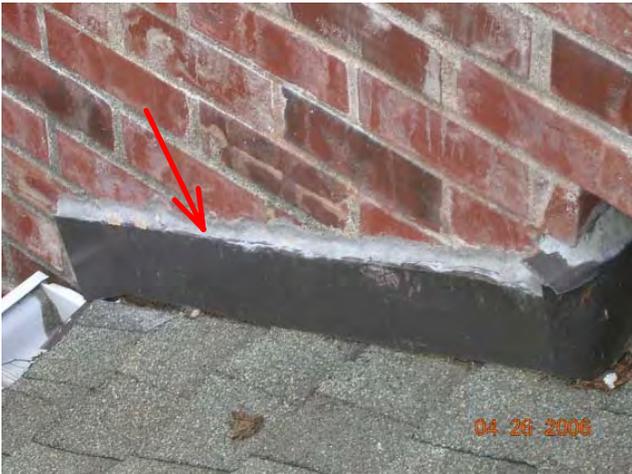
Monitor seam for moisture intrusion  
<chimney flashing front>

**Flashing:** Metal - Non-standard flashing at chimney front left of garage appears serviceable monitor.

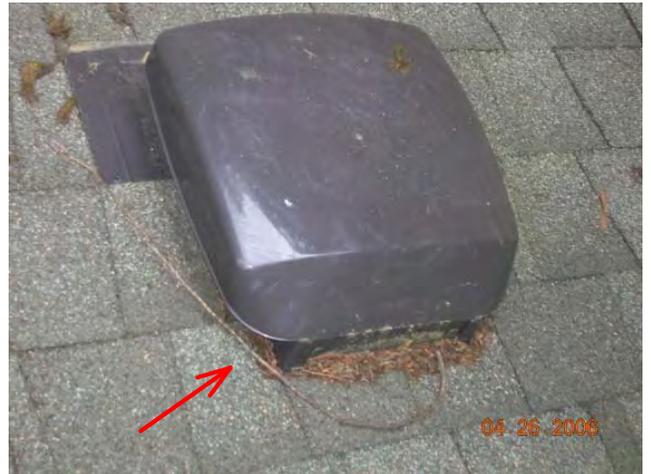
Cut back shingles from vents to allow debris to  
fall away  
<roof>

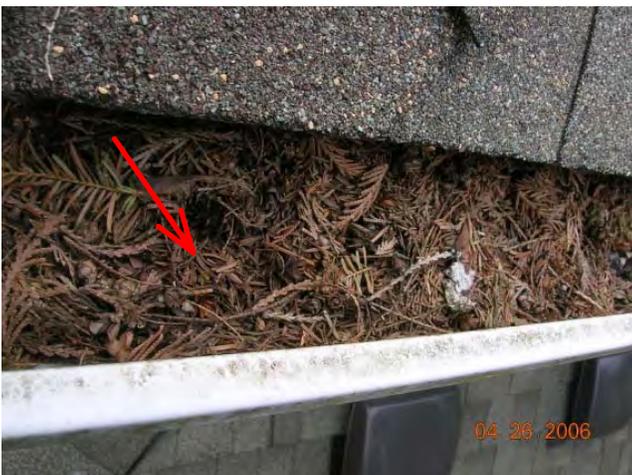
Gutters full of debris <throughout the roof>

**Gutters:** Metal - Full of debris needs to be cleaned.

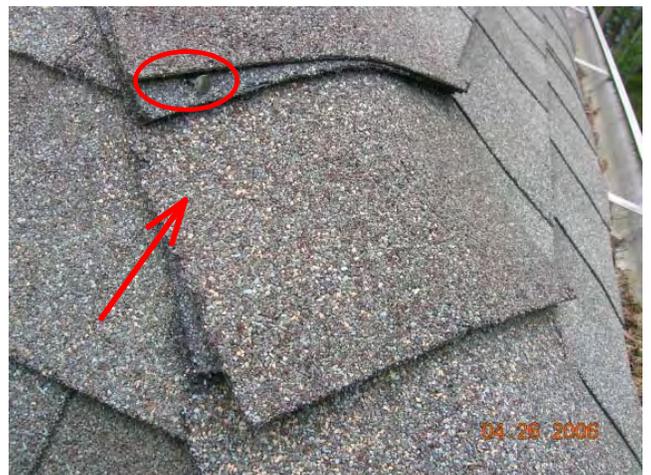
Displaced shingle, exposed fasteners  
<front right ridge of roof>

**Main - Roof Surface - Material:** Asphalt shingle - Loose shingle on lower ridge front right side with exposed fastener <refer to photos for additional details>. [Debris Remove] All debris should be removed from the roof surface so as to aid the performance of the roof covering and/or enhance the appearance of the dwelling. [Moss] The growth of moss on asphalt composition roof coverings can be potentially destructive to the shingles by shortening their normal service life. We recommend employing a professional, who is in the business of dealing with these conditions, to treat the roof to kill the moss followed by a careful cleaning. Inquire with seller regarding the changes to shingles on the ridge and front left of the roof <refer to photos>, unknown reasoning inquire with seller for further details.

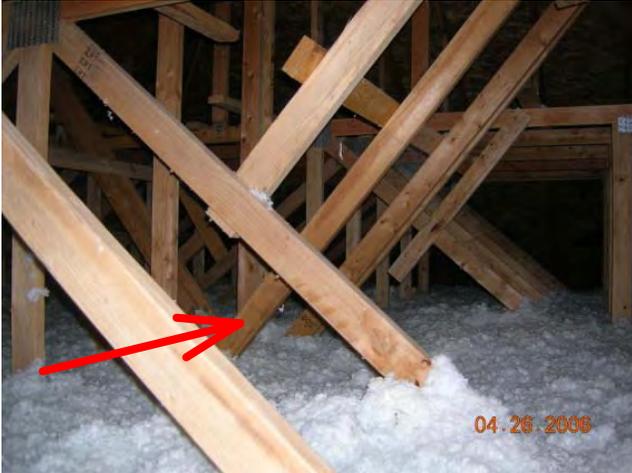
Minimal inspection of attic due to blown insulation and truss roofing system <main attic>

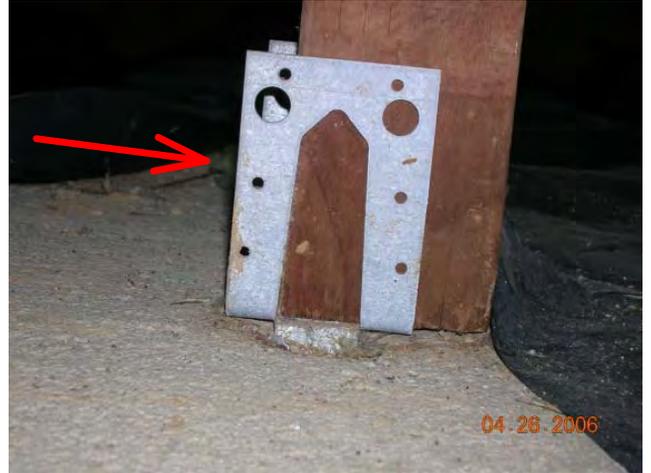
Numerous pier straps missing fasteners to post <throughout the crawlspace>

**Piers/Posts:** Wood posts and cement piers - The floor supports were marginally connected and some not at all, these were subject to failure in the event of excessive soil movement and/or seismic activity. Additional connections or reinforcements should be installed by a qualified foundation contractor.

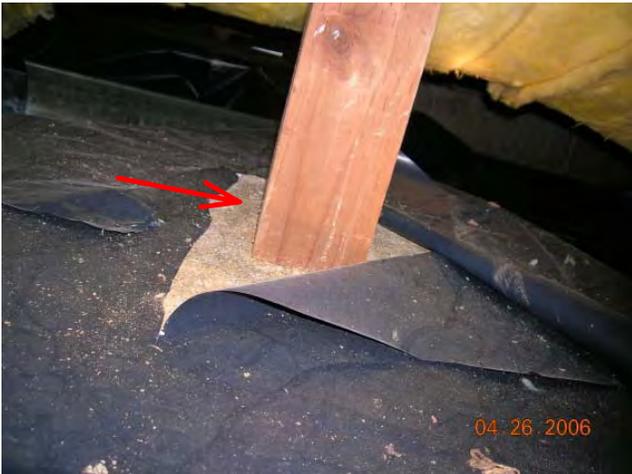
Post/pier missing straps <crawlspace>

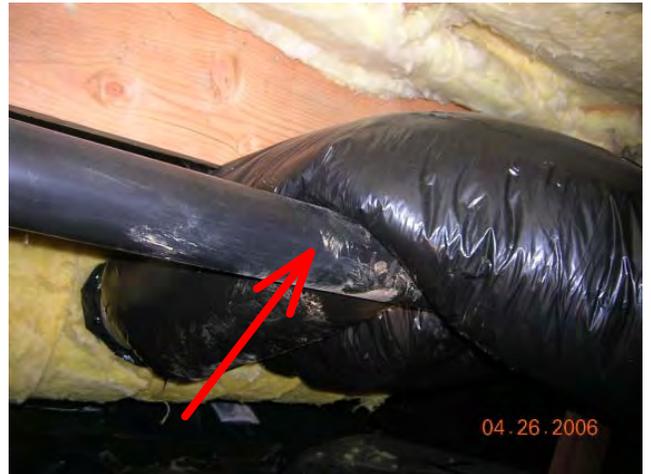
Heat ducting compressed <numerous locations crawlspace>

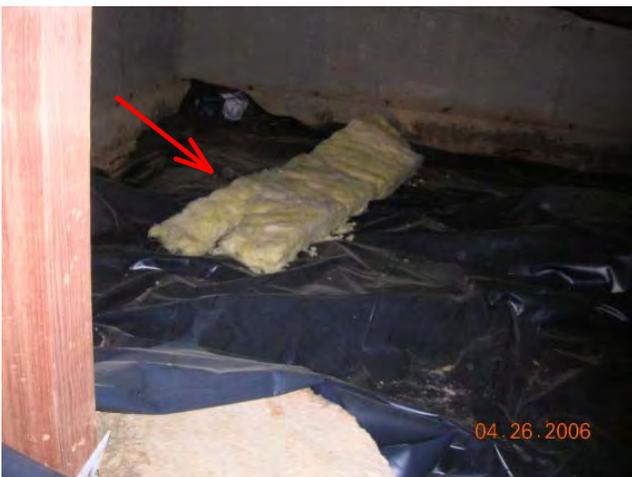
Fallen insulation <crawlspace>

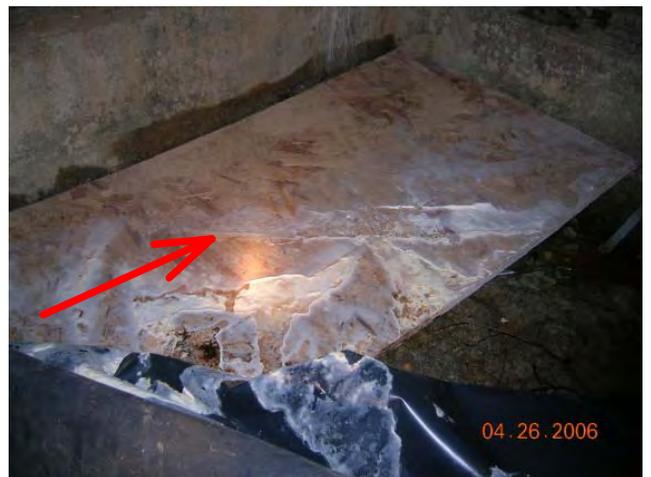
Decaying cellulose debris, conducive condition for wood destroying organisms <numerous locations in crawlspace>

**Main - Crawl Space - Cellulose Debris:** Conducive condition - Cellulose, wood, cardboard or paper debris was present throughout the under building crawl space. This debris provides conditions conducive to rot and wood destroying pest infestation. After "warming up" on this debris pests can then "graduate" to infesting elements of the structure itself. The Washington State Department of Agriculture
